B-52H Overview

2026 Corrosion Technical Interchange Meeting

Structures Engineer, Corrosion Manager
B-52 System Program Office

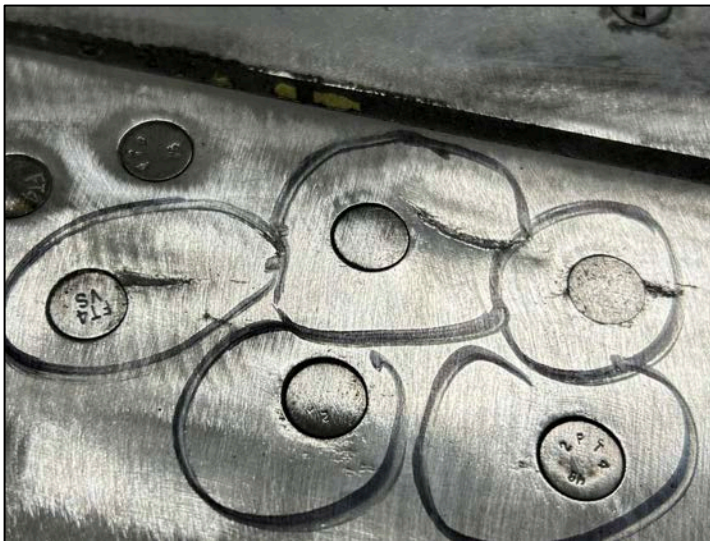
- Intergranular corrosion at steel fastener and aluminum skin interface at front/rear spar chords
- Lap splices between wing skins
- 27 aircraft impacted to date
- Skin replacement efforts in work

UWS Corrosion Example

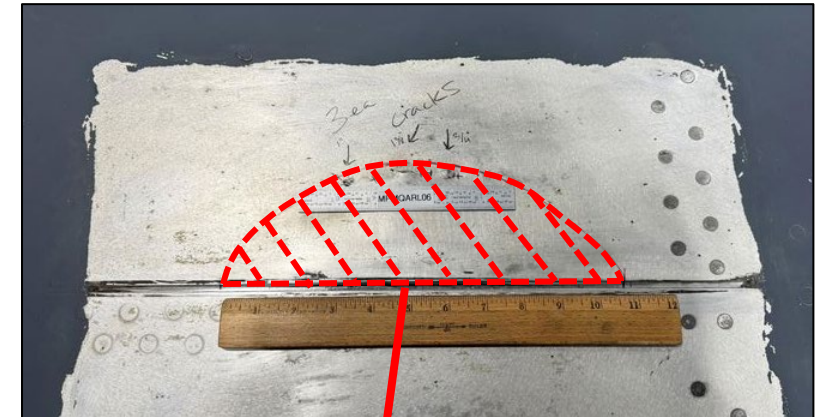
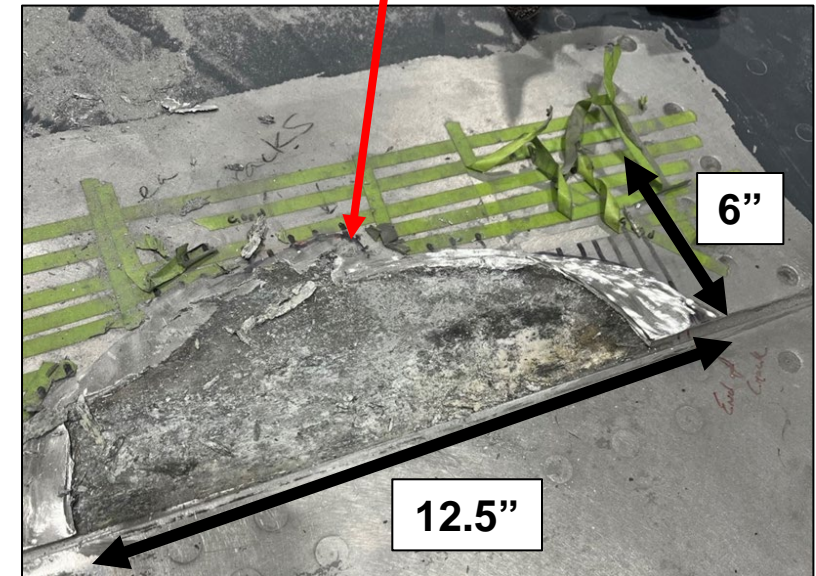
Lap Splice SCC Example

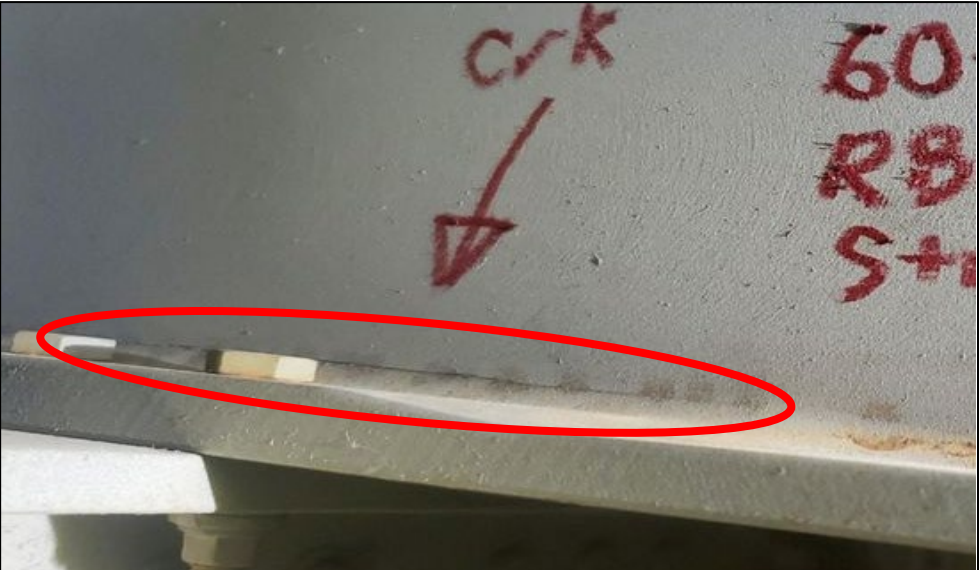
- Stress corrosion cracking typical in lap splice stringers
- Val/Ver planned at PDM soon

CWS SCC Example (UP),
 CWS Top View (TOP RIGHT),
 CWS Cross Section (BOTTOM RIGHT)

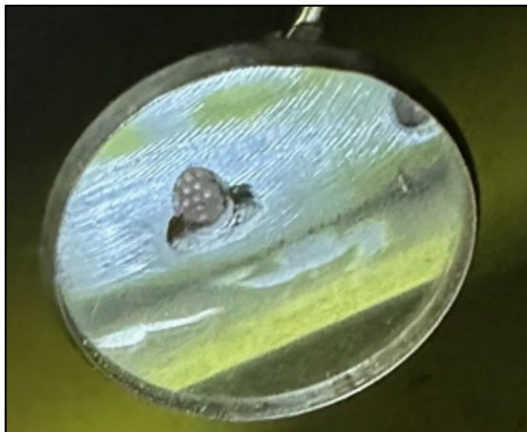
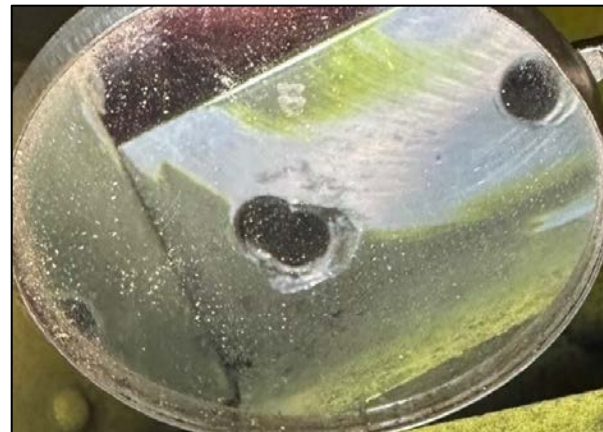
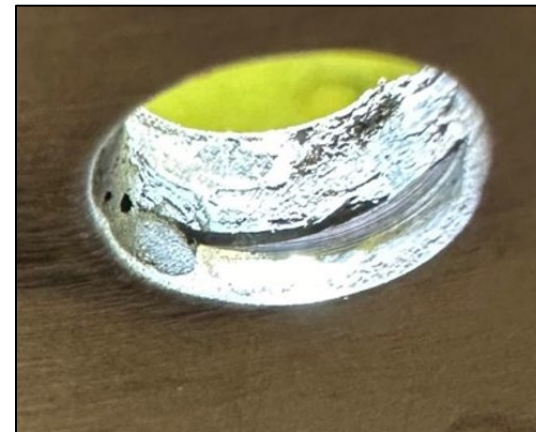
**Horizontal Stab being
Removed at AMARG (UP),
Spar Chord Damage (LEFT)**

- Effort in work to prepare for future repair/overhaul, establish and verify procedures, develop shop aids
- If repair/overhaul is not possible, swapping horizontals may be only solution short of new procurement

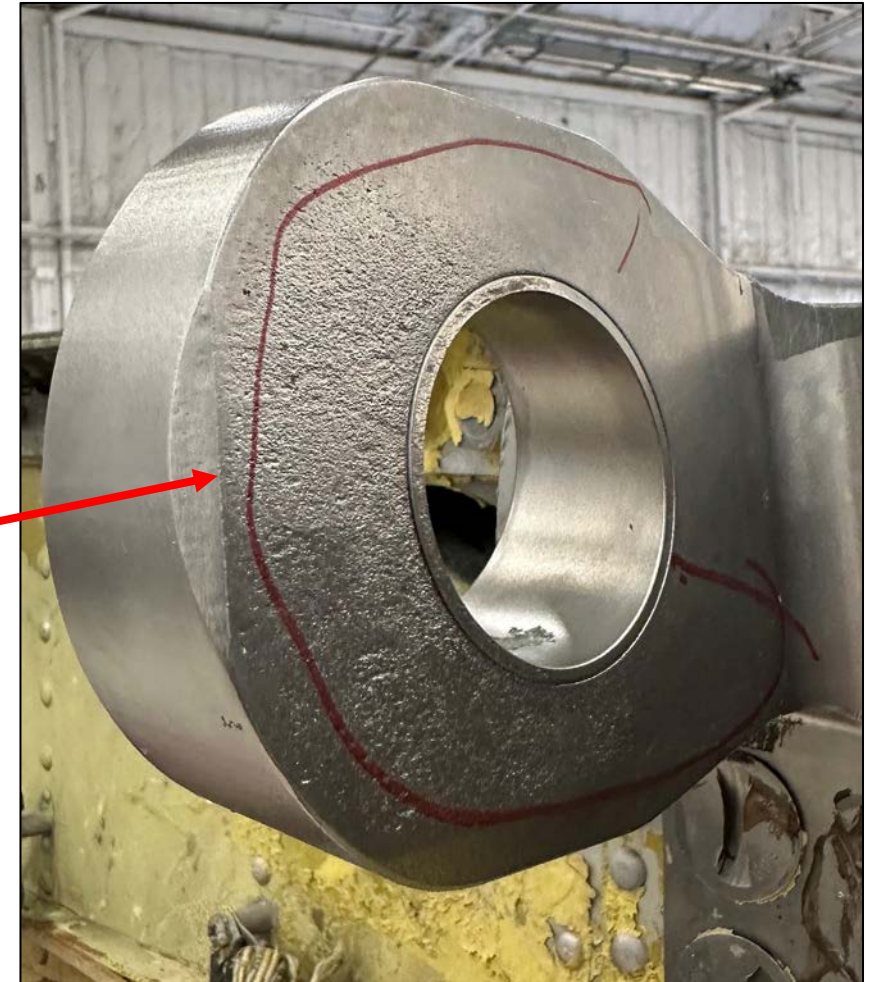
Vertical Stab Fitting Lug

- Pitting on lug faces
- Effort underway to develop removal and replacement procedures
- Root cause possibly identified and corrected, must now deal with impact

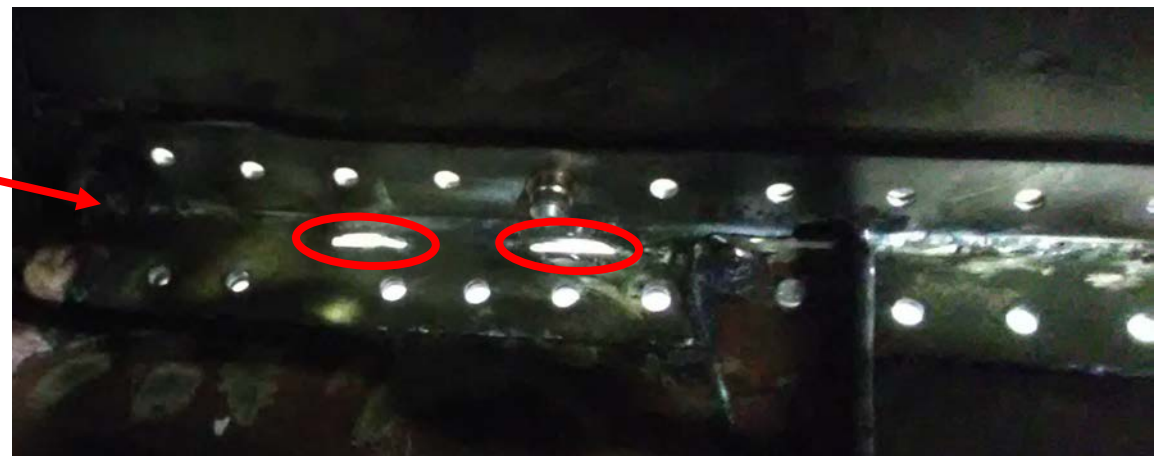
- Closure beams, 20Y fittings, mid spar
- Efforts in work to replace major structure

20Y Fitting (TOP), Closure Beam Corrosion (BOTTOM)

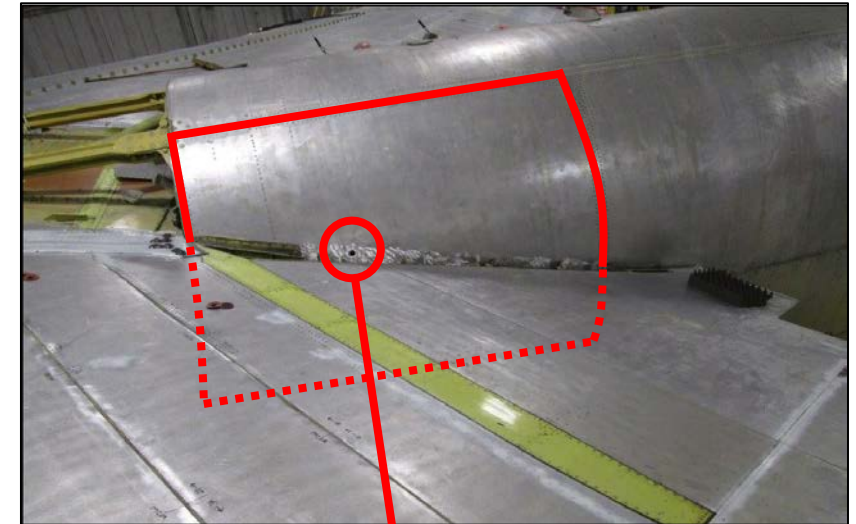
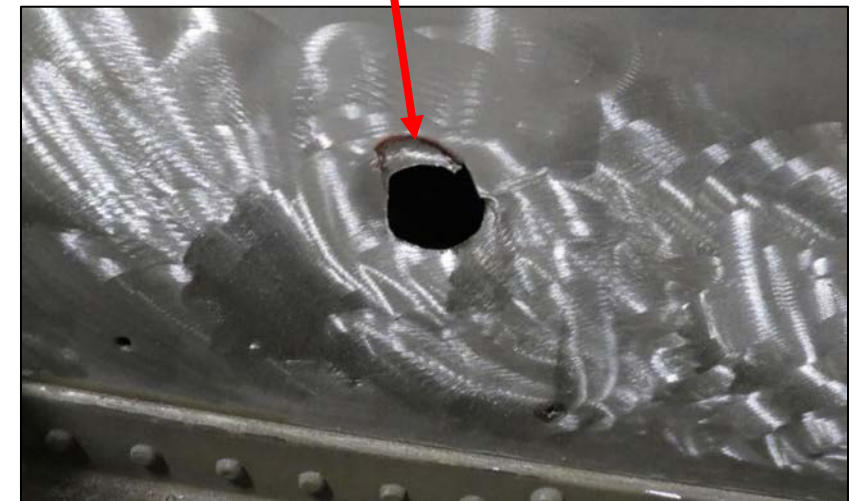
Fuselage side skins

Damage Before Removal

- BS 694-805 replaced recently
- Several other skins already replaceable or in work

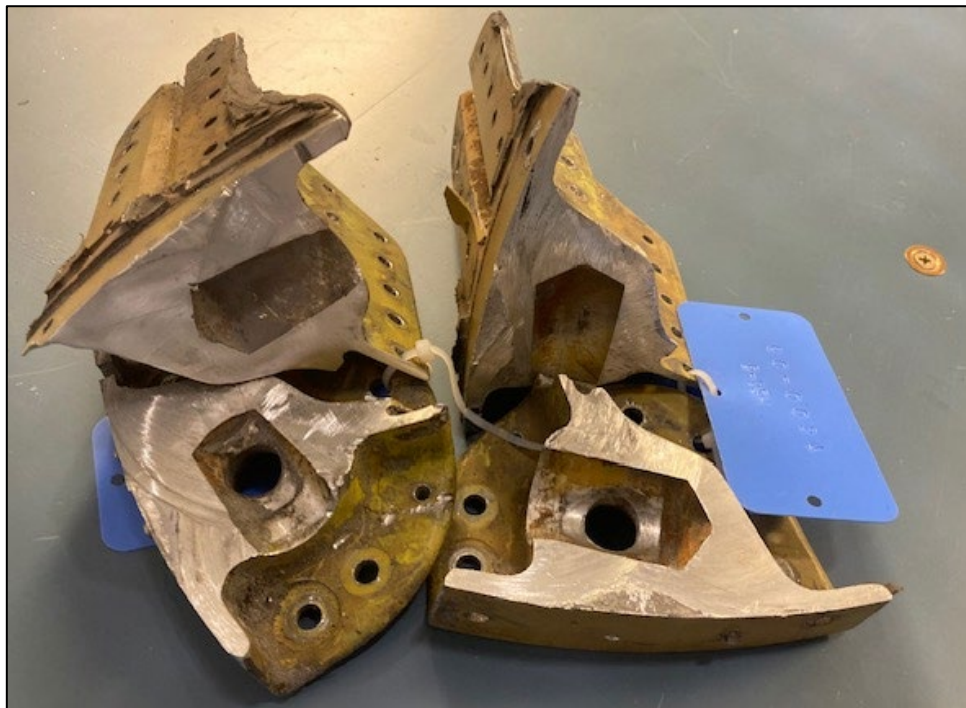
- Water intrusion through chute door caused corrosion and SCC to mid and lower fittings
- Once-through-fleet replacement in work

Cracked Fittings

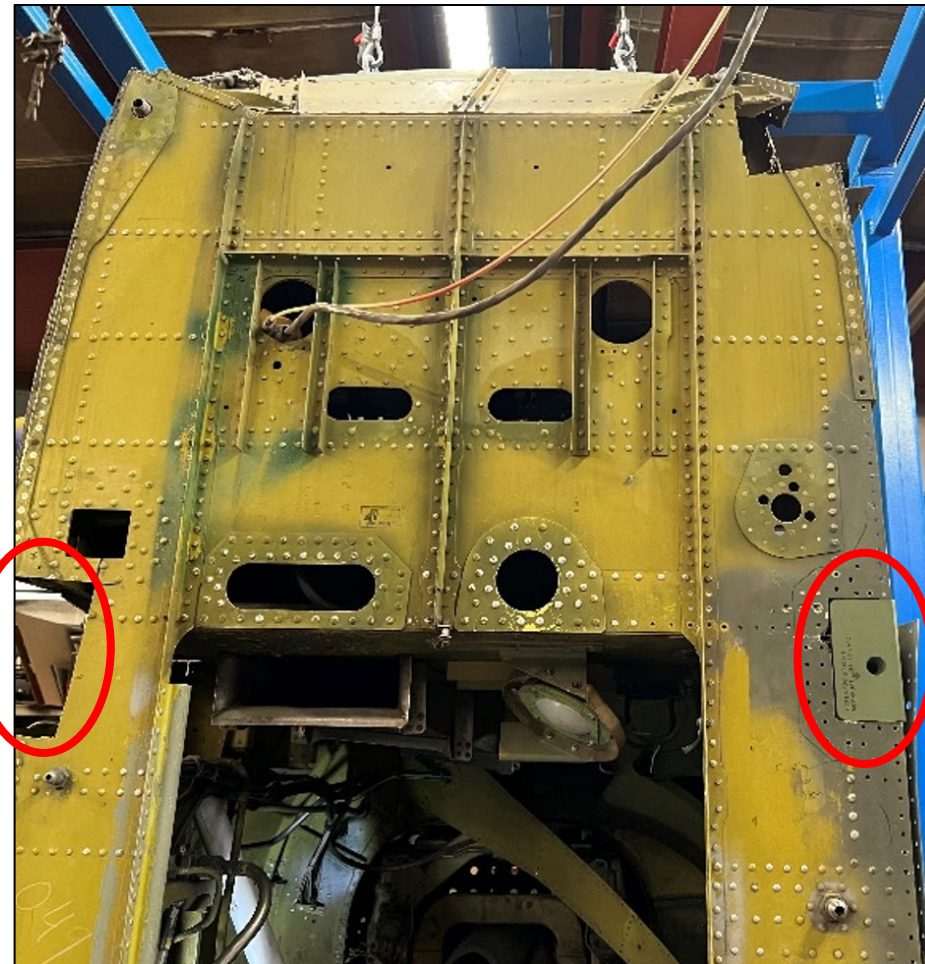
Tail Section Fitting Replacement
