# C-130 Corrosion Prevention and Control

March 2026

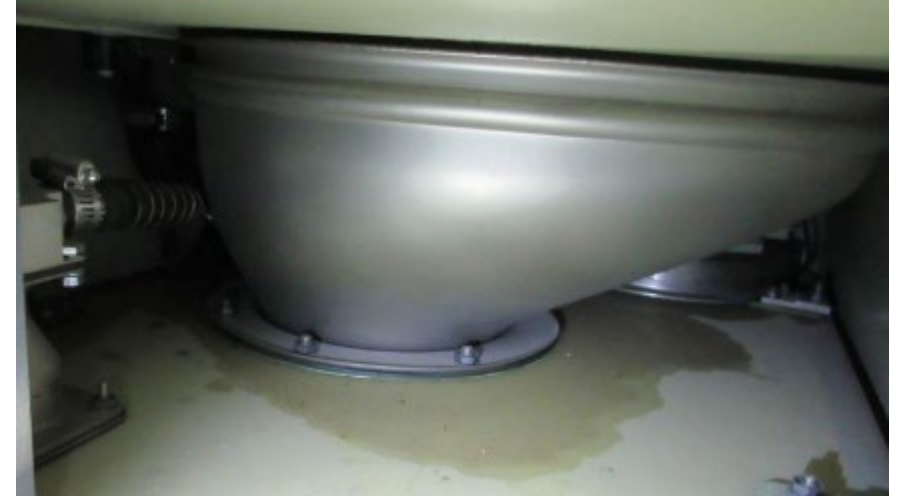
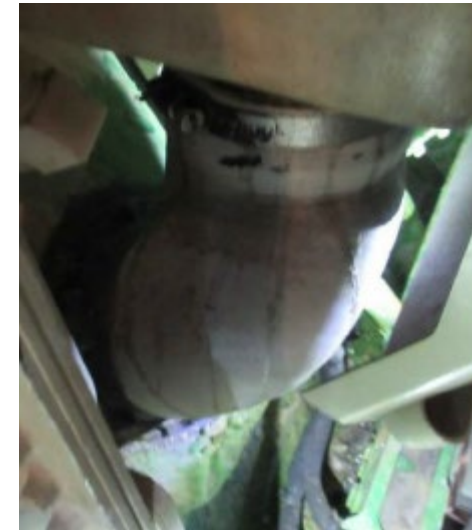
# Aircraft Washes – Frequent Problem Areas

- Critical to check the toilet area during interior wash and during the after-wash corrosion inspection
  - Leaks from toilet servicing line have led to severe corrosion on FS 737 structure
  - Leaks from bowl/tank interface or other areas of the tank have led to corrosion of toilet support structure (pedestal)
  - Also covered during BPO/PR zonal inspections
- Recent updates to the wash checklist TOs:
  - Mask over damaged or missing weather excluding patches prior to wash and replace patches after wash
  - Remove Nose Wheel Well Armor (if installed) before wash
  - Inspect windshield wiper assemblies for corrosion during after wash corrosion inspection
  - Requirement to post cleaning compounds used and mix ratios near wash equipment

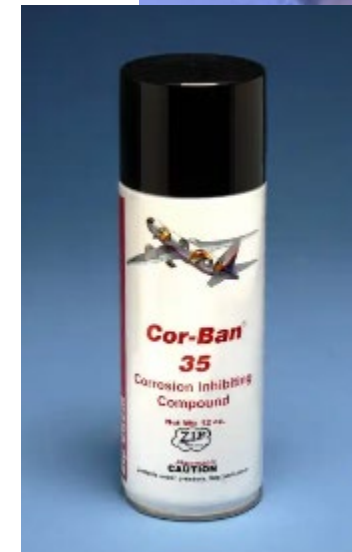
## Early CPC Application

- FS 517 MLG beam corrosion issue highlighted the need for early, widespread application of CPCs to high corrosion risk aircraft structure
  - Wing trailing edges, latrine area, wheel wells
- AFSOC applying CPCs to AC/MC-130J aircraft using OSDs contract support at Hurlburt Field
- Additional UDLM effort in work for HC-130J aircraft
  - Likely to be worked as a drop-in requirement at Robins AFB

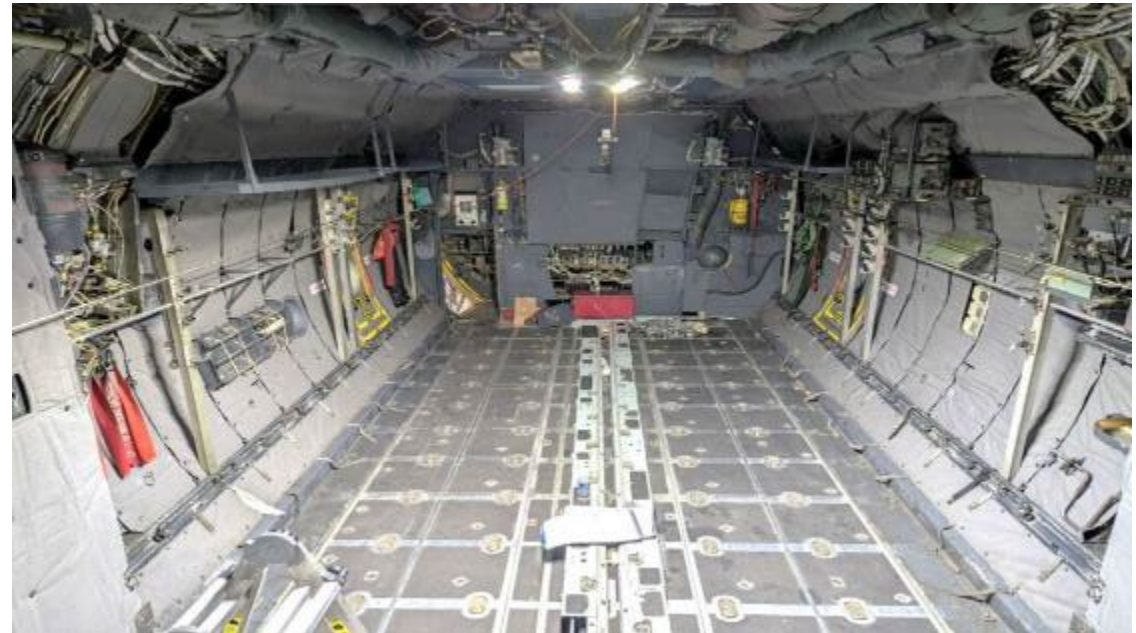
Improved Thermal Acoustic Blanket (ITAB) and Improved Batting Acoustic and Thermal (IBAT), developed by Cocoon, Inc.:

- Utilizes breathable hydrophobic materials to prevent corrosion on aircraft interior
- Improves durability of the blanket system
- Improves attachment system to prevent dropped objects from around cargo ramp and cargo door
- Installation completed June 2024
- 540-day evaluation ended Jan 2026
  - Final report being compiled for determination of fleet modification

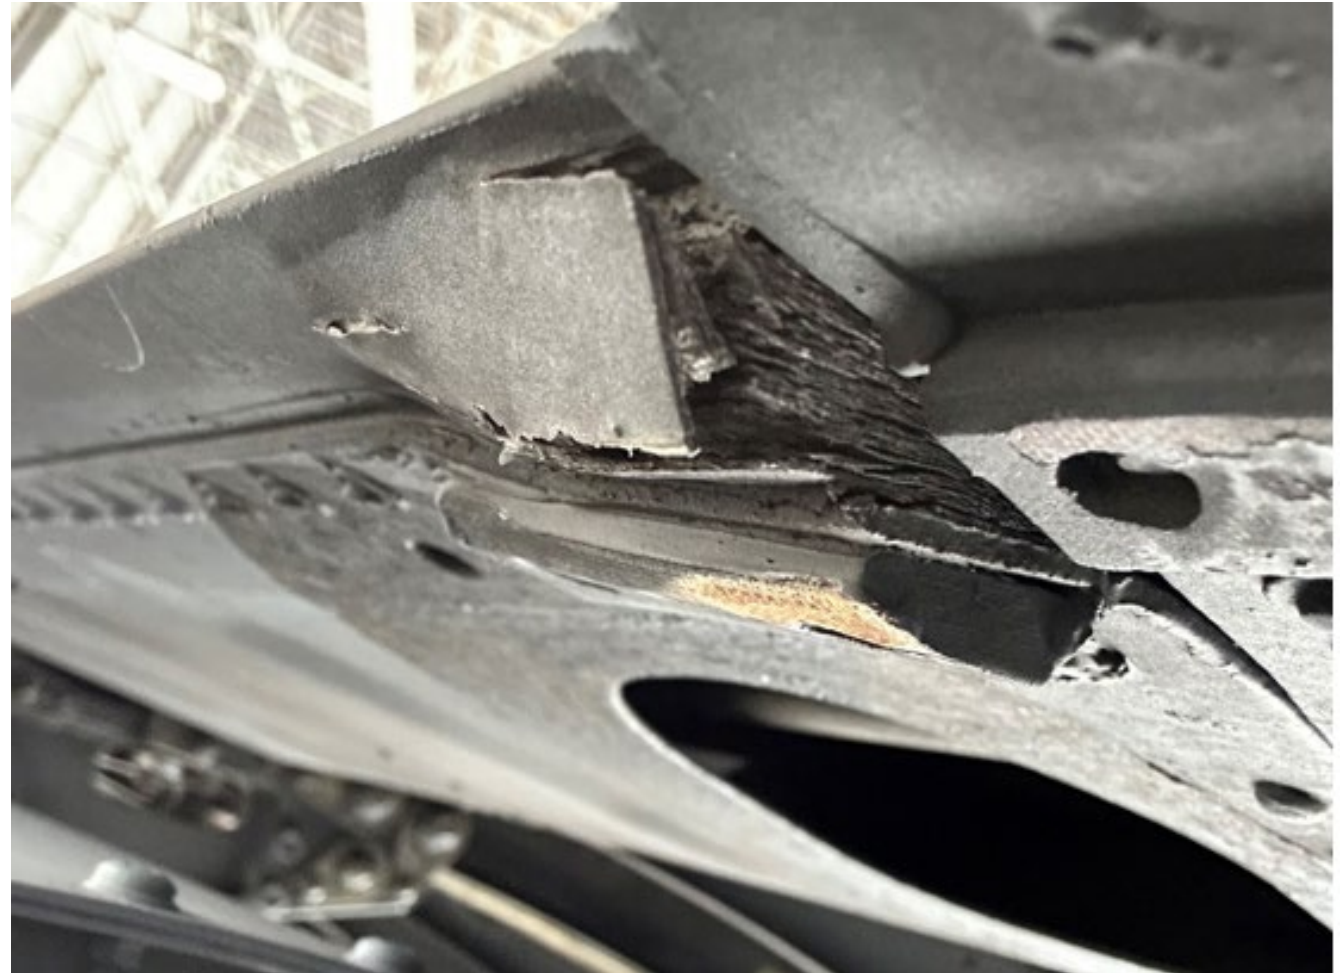
## Trailing Edge Strip Corrosion (C-130J)

- Aluminum extrusion sandwiched between carbon fiber upper trailing edge skin panel and trailing edge pans
- Corrosion initiates in fastener holes or along the forward (internal) edge of the trailing edge strip
- Lockheed investigating material substitutions and new finish options
- New corrosion prone areas section of 1C-130J-23 will be published
- Exacerbated by missing weather excluding patches

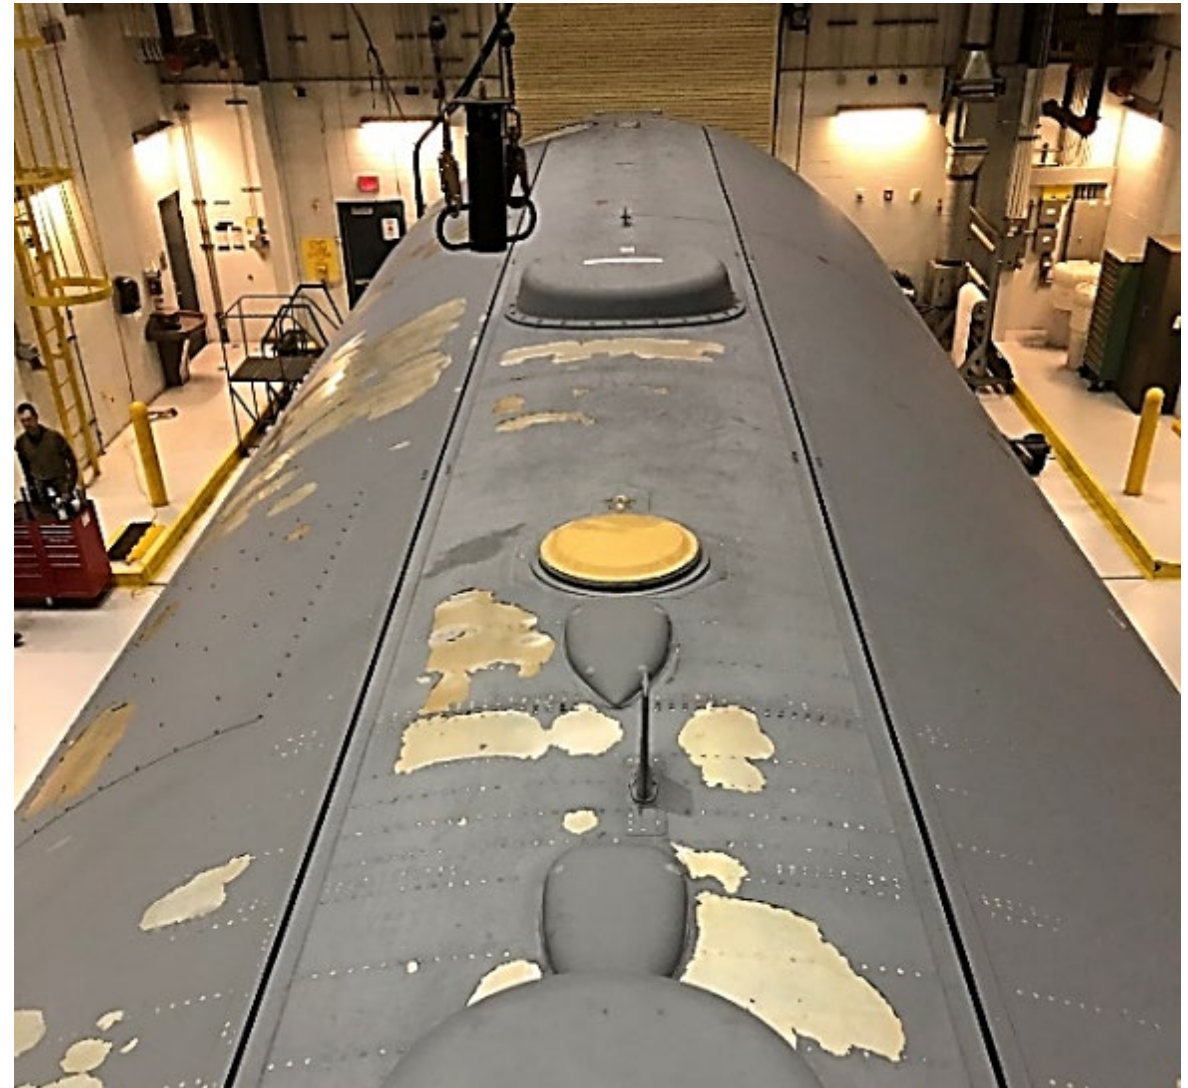
## TCTO 1C-130J-1191 – *Inspection of Outer Mold Line Coating System for Peeling or Missing Coatings*

- Replacement for TCTO 1C-130J-1131
- Production aircraft experiencing paint adhesion failures down to substrate
- TCTO results used to inform need for strip vs scuff sand at mid-cycle paint
- Corrective actions implemented by LM have decreased prevalence of issues, this TCTO pushes the initial inspection back to first B Check after delivery of aircraft

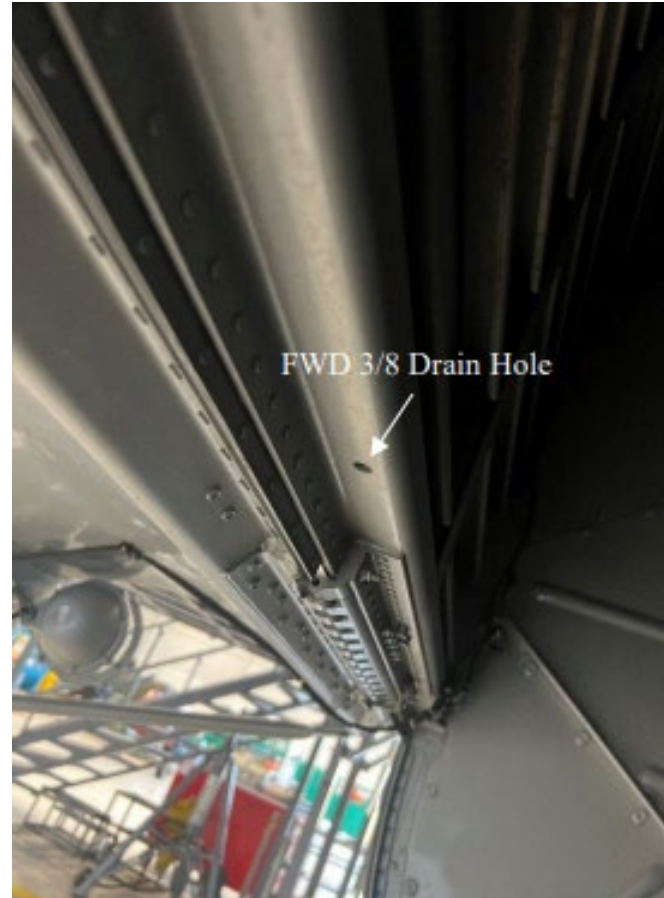
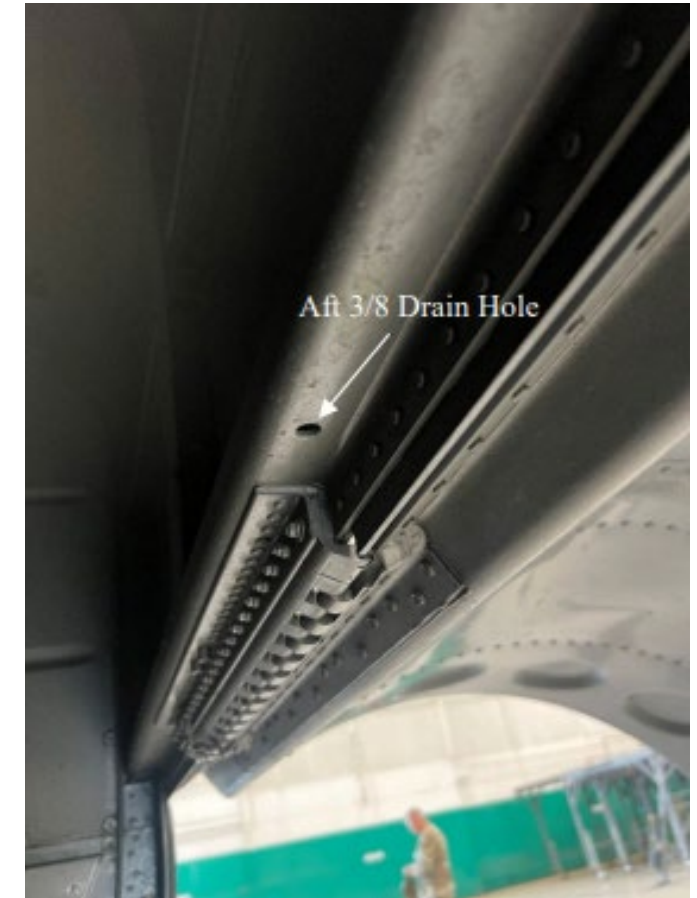
## TCTO 1C-130J-1202 – *Inspection of Main Landing Gear (MLG) Wheel Well Drain Holes at Water Line 159*

- Addresses a potential corrosion issue caused by water entrapment in the MLG wheel wells
- Inspection of wheel well Zee angles to verify drain holes are present
  - If missing drain holes, install per TO 1C-130J-23, 53-10-00, Paragraph 53.20.1 and restore finish

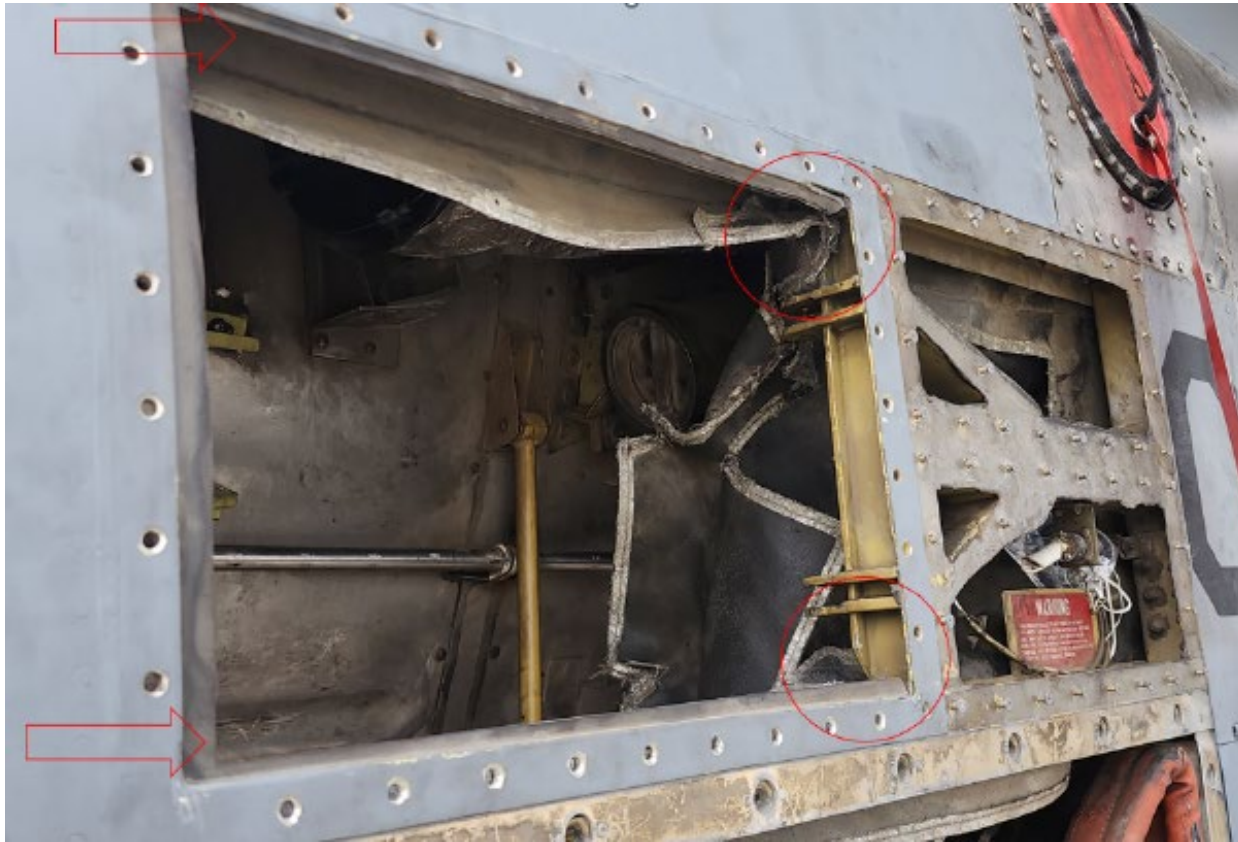
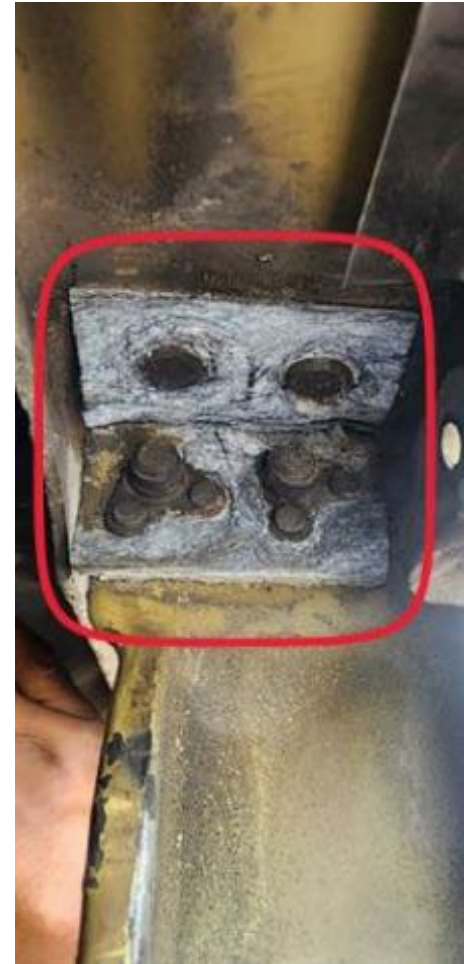
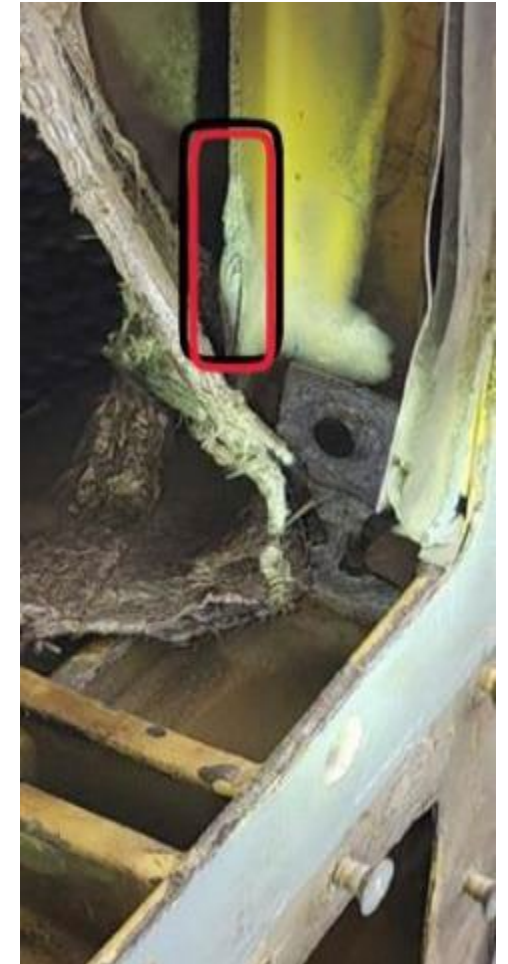
## APU Compartment Corrosion

- Corrosion detected during APU duct installation
- Removal of APU, insulation materials, and firewall panel revealed extensive corrosion on longeron and inside compartment
- Lockheed Martin actions:
  - Corrosion inspection TCTO
  - Update structural repair manual
  - Recurring detailed/directed inspection requirement and interval of complete MLG pod area, left and right
  - CPC application requirements
