B-52H Overview

2026 Corrosion Technical Interchange Meeting

Structures Engineer, Corrosion Manager
B-52 System Program Office

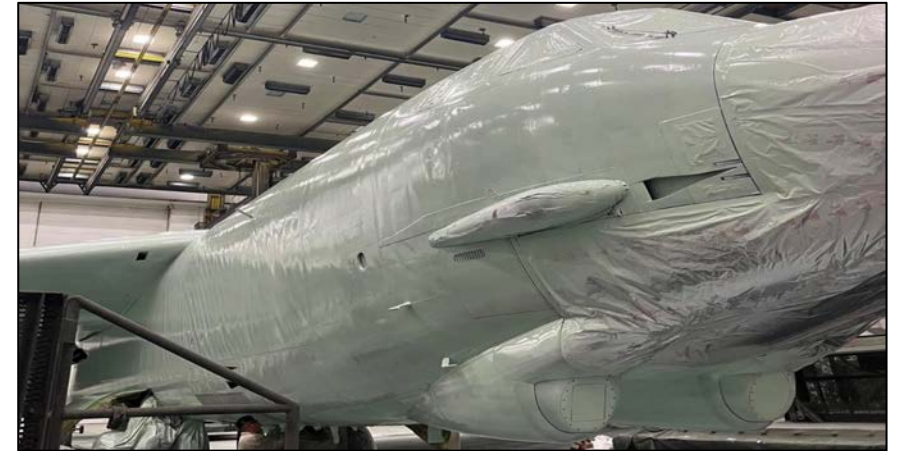
Aircraft with Non-Chrome Primer

A couple aircraft have returned to depot with non-chrome primer applied last PDM

- Results appear promising

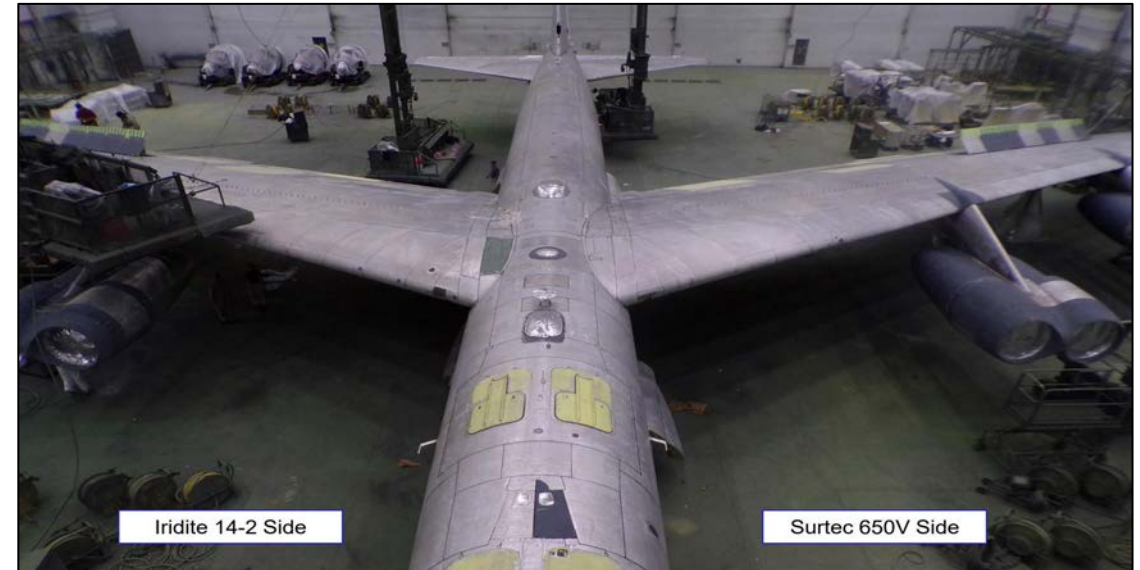
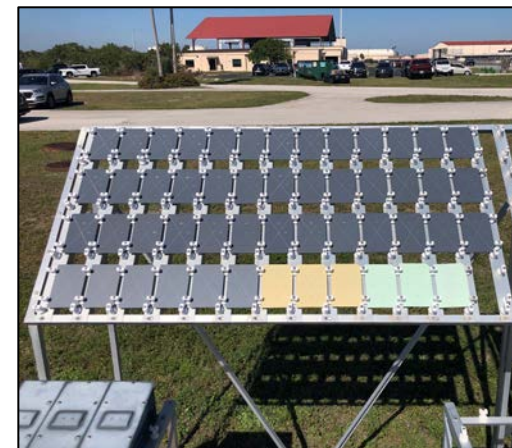
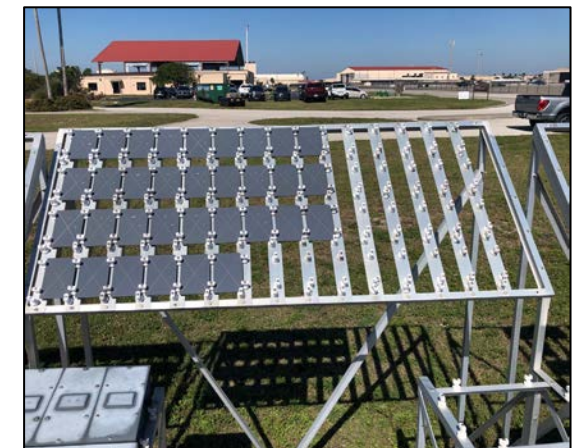
**Tri-Chrome Demo Aircraft 60-0033 (TOP RIGHT),
Test Panels at Patrick SFB (BOTTOM RIGHT)**

On-aircraft evaluation completed on 60-0013, currently ongoing with 60-0033

- **60-0013 results appeared promising**

Test panels at Patrick SFB

- **Several tri-chrome pretreatments, Class N primers, topcoats**
- **Non-isocyanate topcoats**
- **Deployed Feb 2025, likely to remain out for 2-3 years**

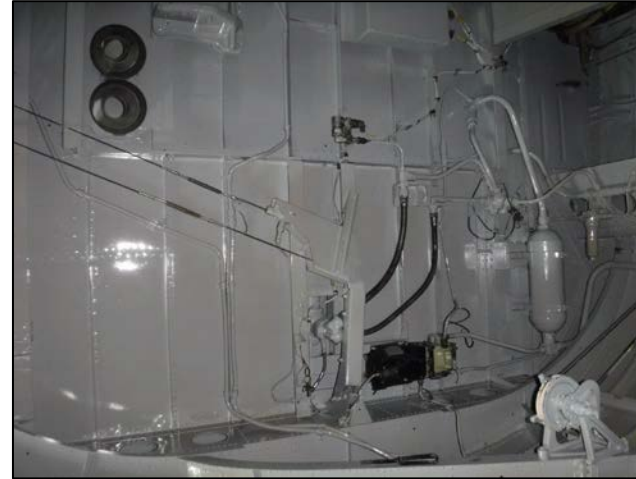
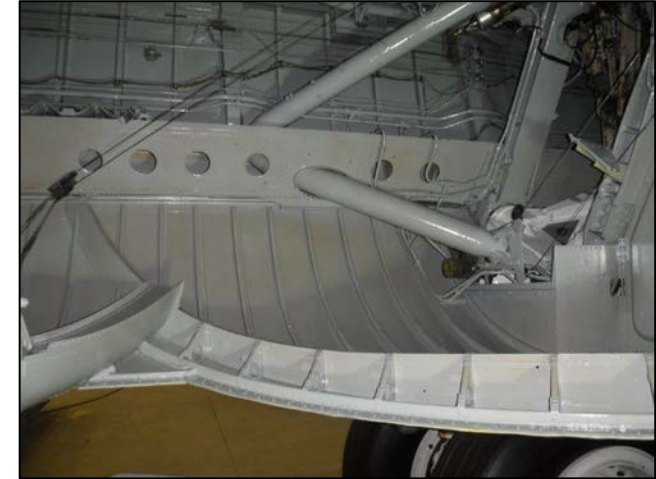
ABWW Final Product

Aft Body Wheel Well (ABWW)

- Implemented at PDM in FY25
- 9 A/C completed to date

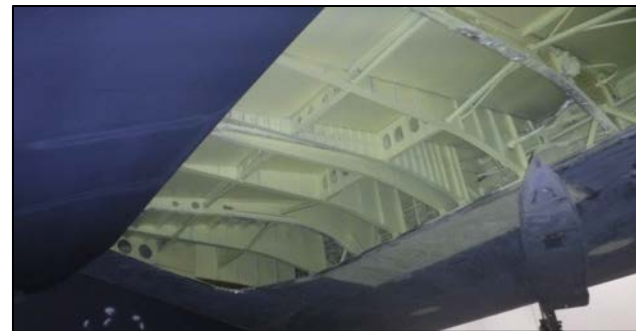
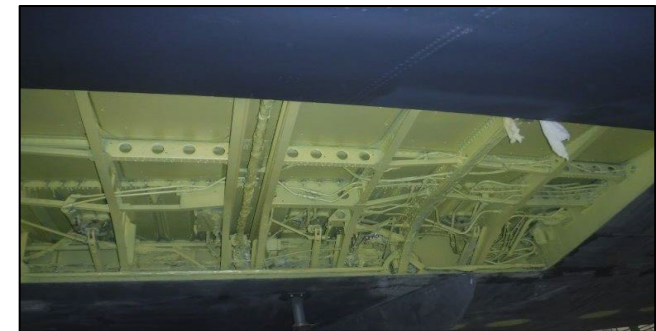
FTGW Final Product

Flap and Tip Gear Well (FTGW)

- Working for PDM implementation
- 1 Val/Ver completed to date

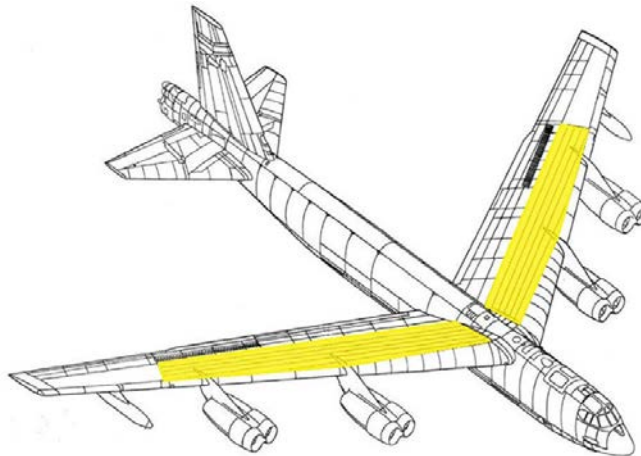
UWS Diagram

Upper wing skins (UWS)

- Intergranular corrosion at steel fastener and aluminum skin interface at front/rear spar chords
- Lap splices between wing skins
- 27 aircraft impacted to date
- Skin replacement efforts in work

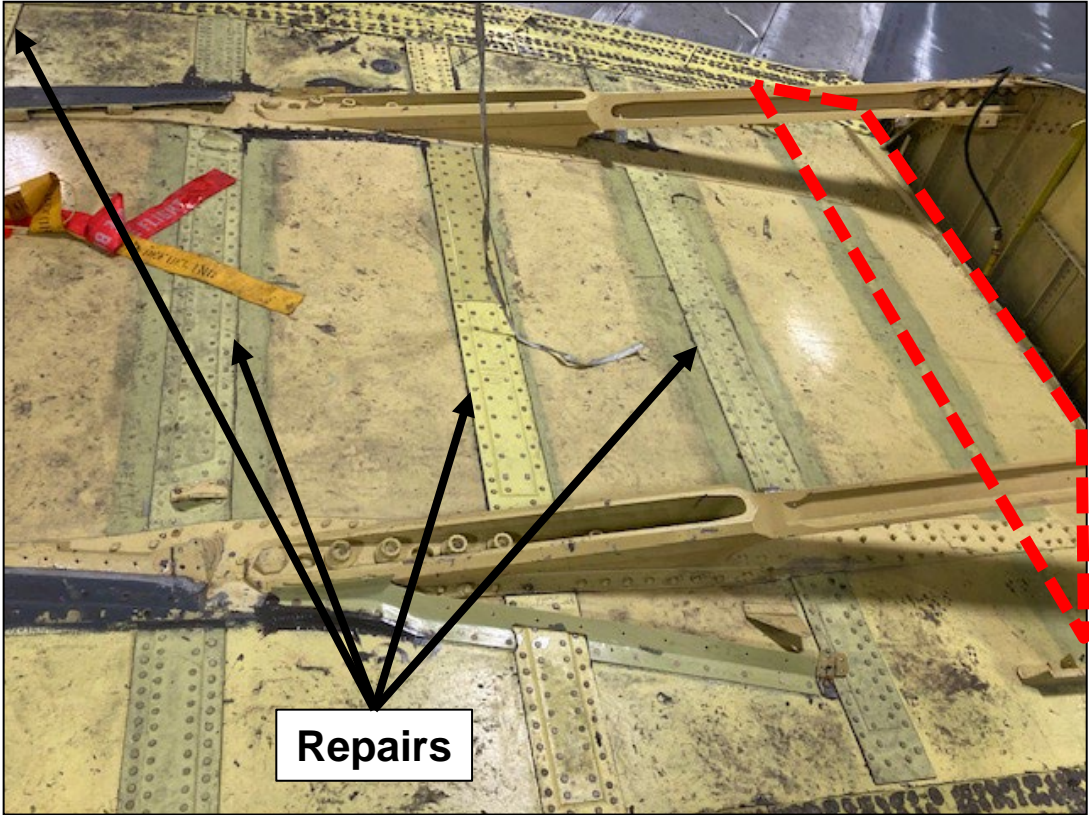
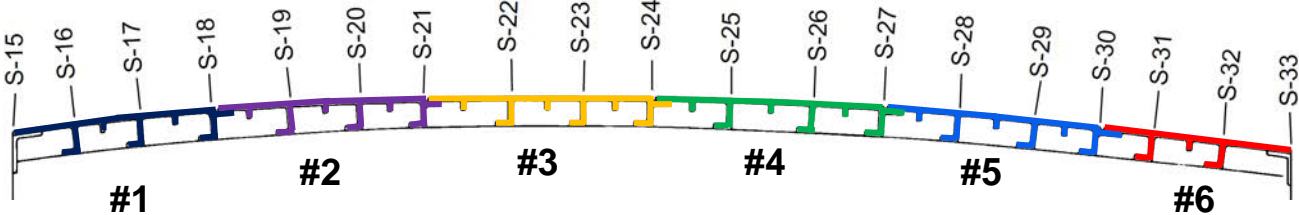
Center wing skins (CWS)

- Stress corrosion cracking typical in lap splice stringers
- Val/Ver planned at PDM soon

CWS SCC Example (UP),
 CWS Top View (TOP RIGHT),
 CWS Cross Section (BOTTOM RIGHT)

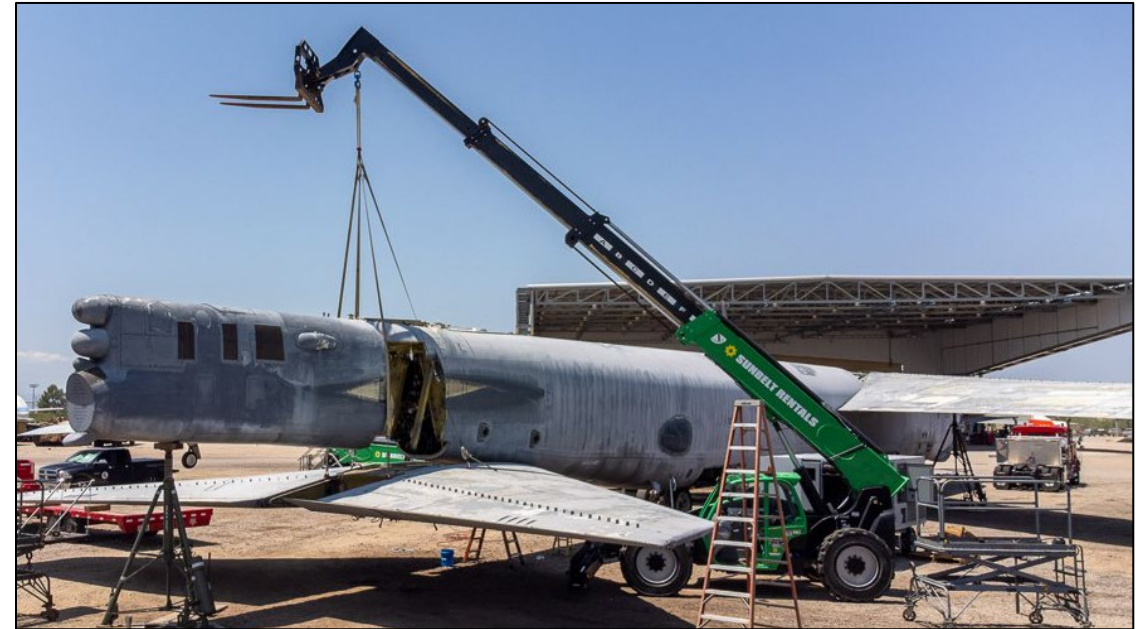
Horizontal stab spar chords

**Horizontal Stab being
Removed at AMARG (UP),
Spar Chord Damage (LEFT)**

- Effort in work to prepare for future repair/overhaul, establish and verify procedures, develop shop aids
- If repair/overhaul is not possible, swapping horizontals may be only solution short of new procurement

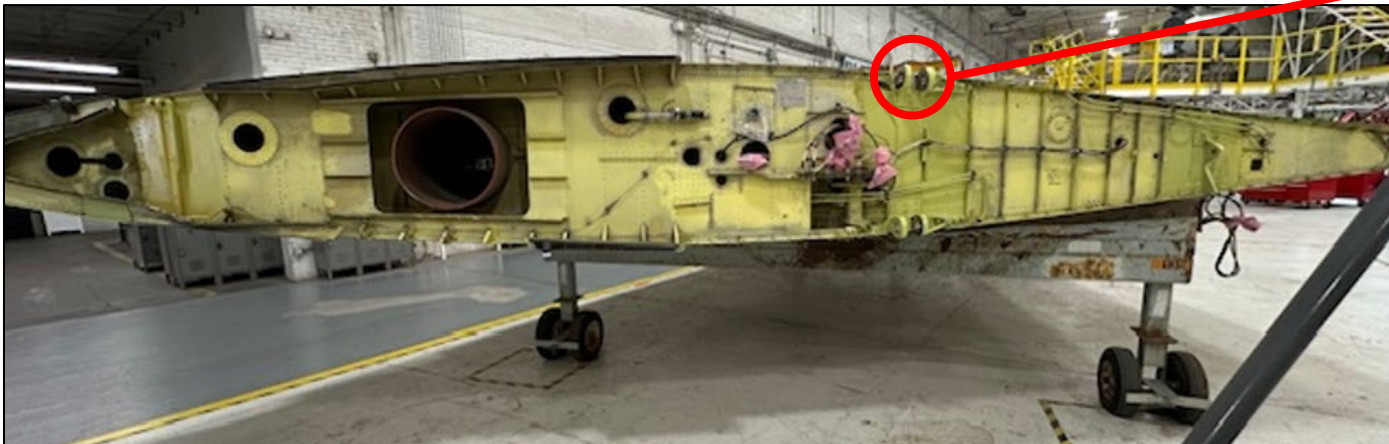
Vertical Stab Off-Aircraft (Laying on Side)

Vertical stab fittings

- Pitting on lug faces
- Effort underway to develop removal and replacement procedures
- Root cause possibly identified and corrected, must now deal with impact

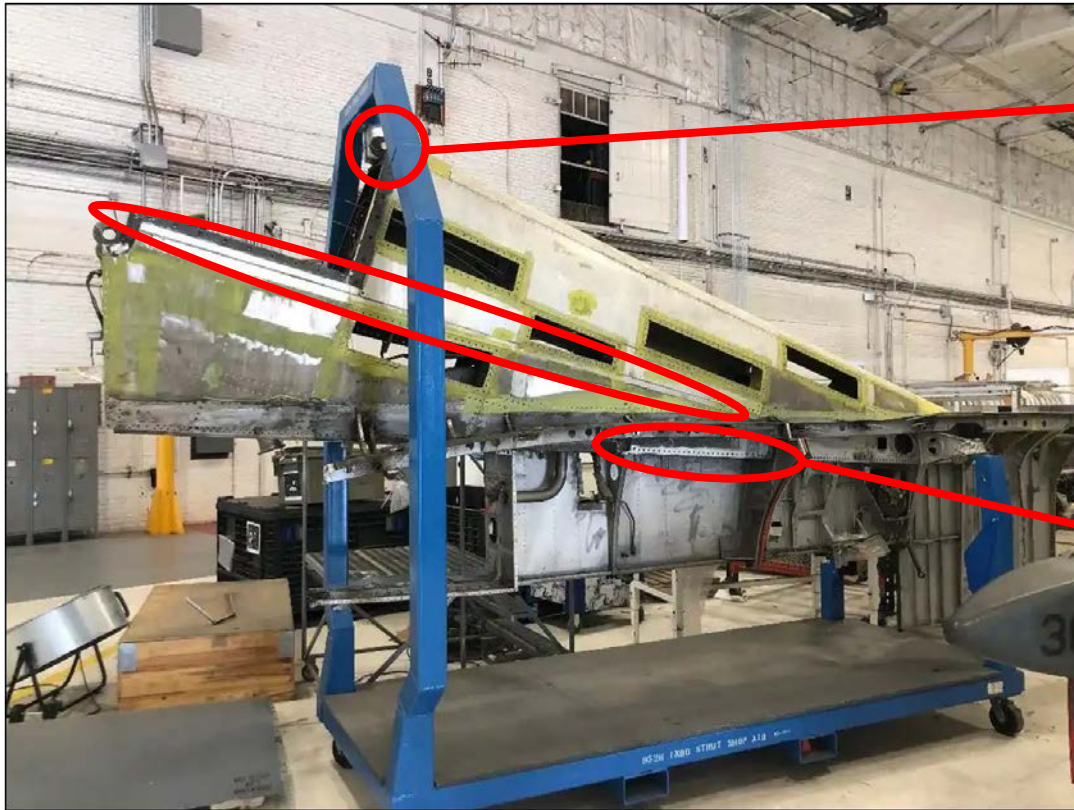
Engine Strut

Engine struts

- Closure beams, 20Y fittings, mid spar
- Efforts in work to replace major structure

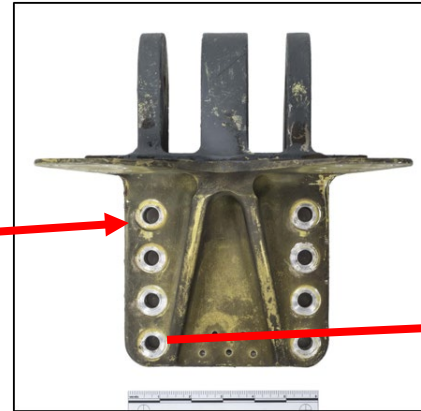
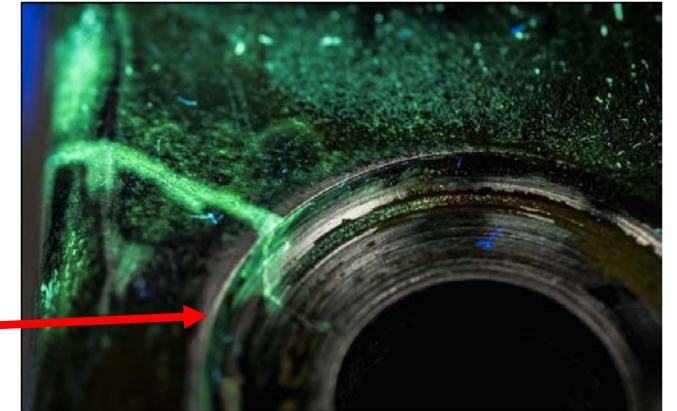
20Y Fitting (TOP), Closure Beam Corrosion (BOTTOM)

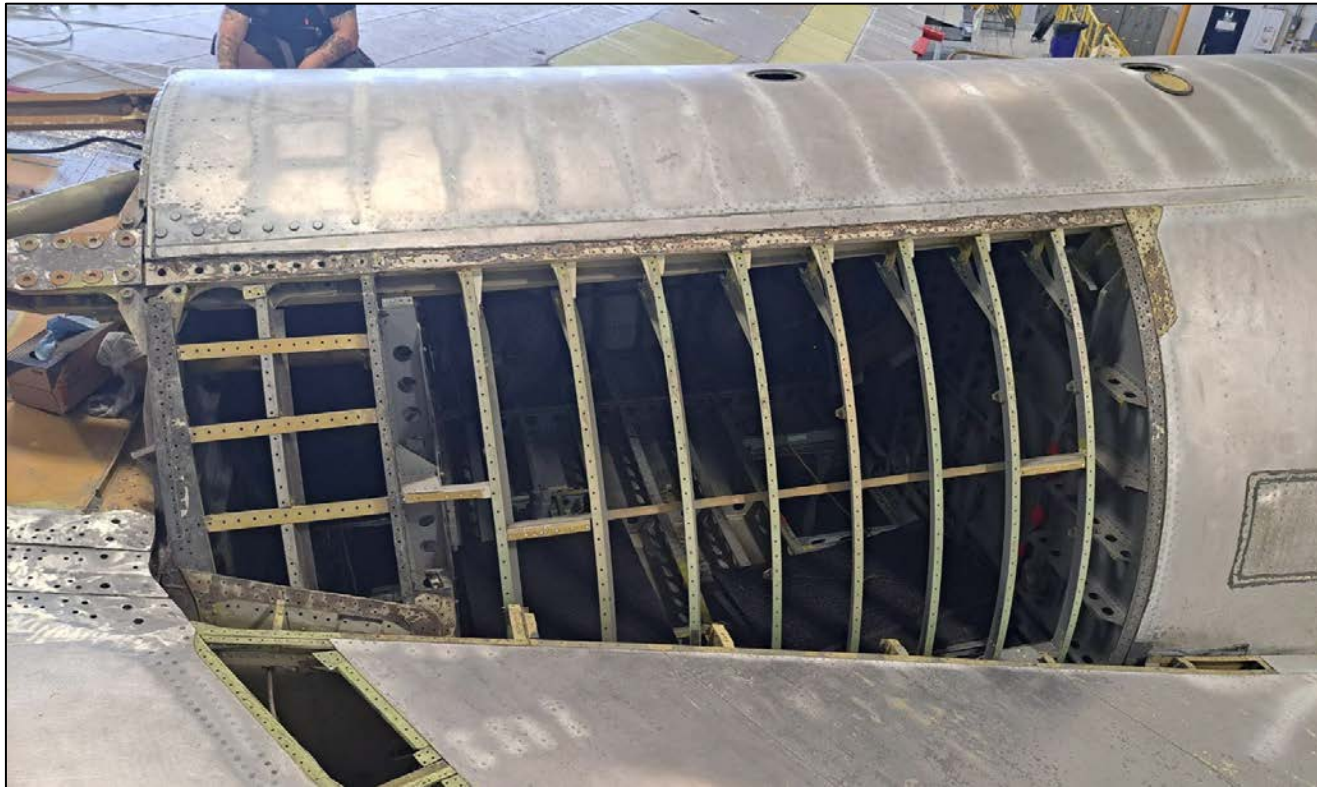
Side Skin Removed

Fuselage side skins

- BS 694-805 replaced recently
- Several other skins already replaceable or in work

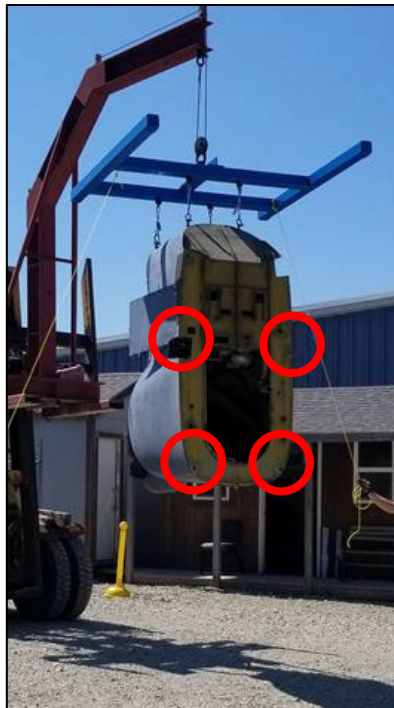
Tail Removed

BS 1853+40 fittings

- Water intrusion through chute door caused corrosion and SCC to mid and lower fittings
- Once-through-fleet replacement in work

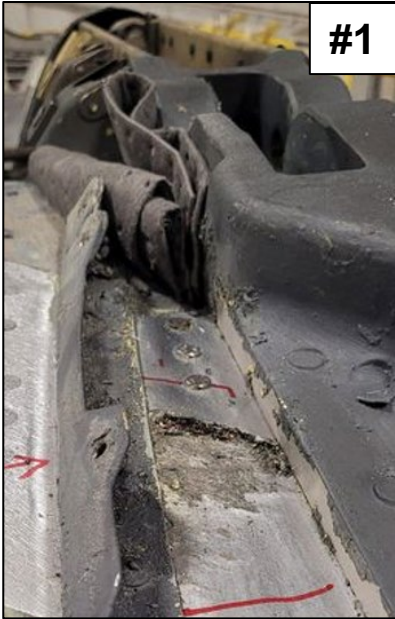
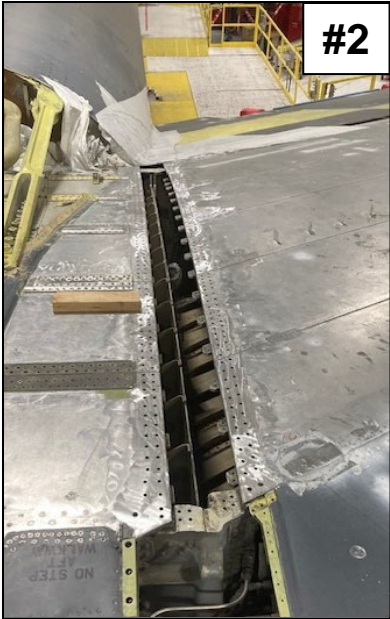
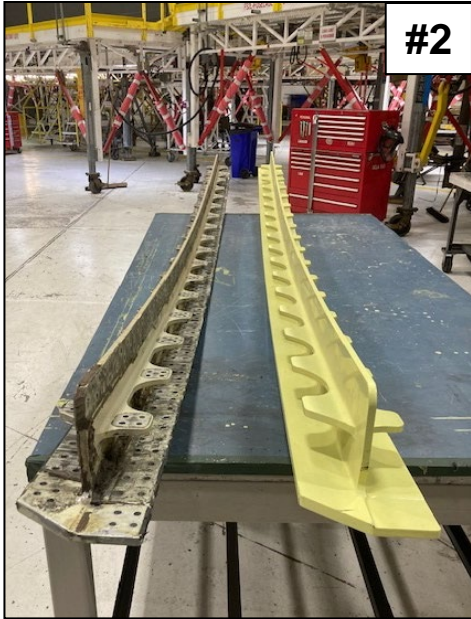
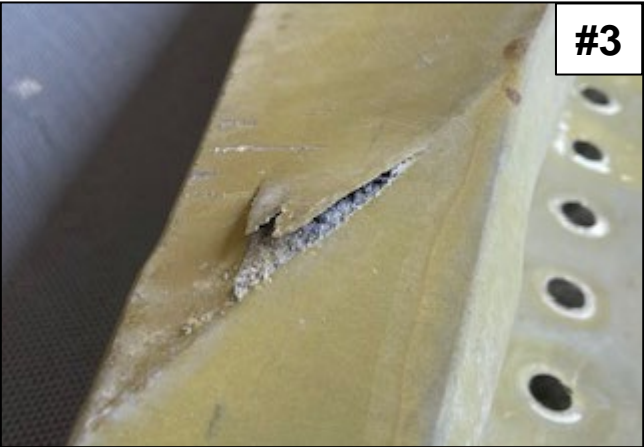
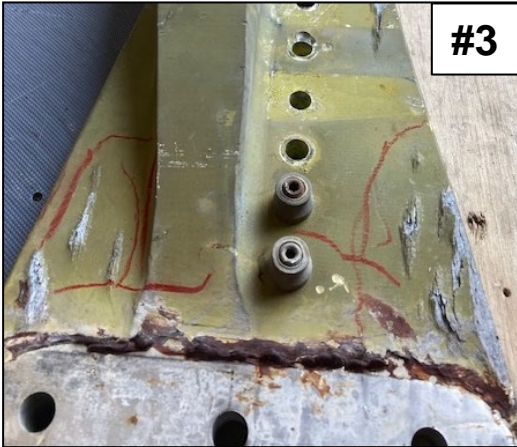
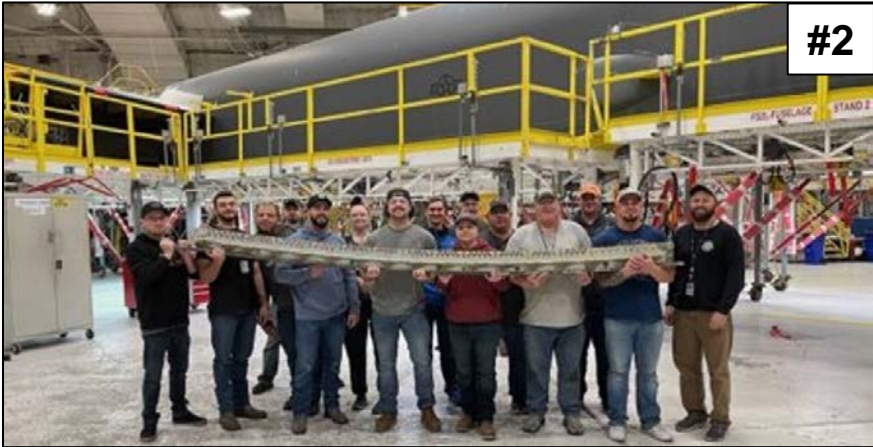
- Front/rear spar terminal fittings
- BL55 splice plates
- Strut kneecaps (#1)
- BL55 rib chord (#2)
- Stub longerons (#3)
- Lower longerons
